## Successful Retrieval of an Embolized JR Catheter Tip from Diseased Left Main

In developing countries reuse of resterilized catheters is very common due to limited resources and this increases the chances of catheter breakage and embolization. This can endanger the patient's life and cause panic in operating room. We are reporting this case of Judkins Right catheter tip breakage and embolization into diseased left main and its successful retrieval by entrapment with simple balloon technique.

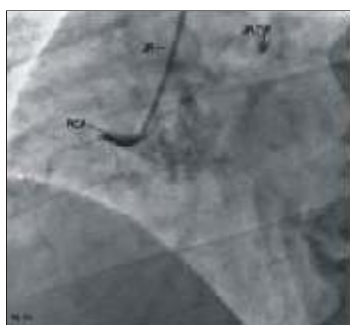
**Fig. 1a :** LAO view showing selective RCA Catheterization with JR3.5 catheter. Catheter tip Appears fractured & embolized

A 6F Judkin's left (JL) 4.0 catheter (Newtech, New Delhi, India) was used to cannulate left coronary artery and angiogram done which was showing distal left main 90% stenosis, proximal left anterior descending artery 90% stenosis and mid left circumflex artery 90% stenosis. A reused sterilized 6F Judkin's right (JR) 3.5 diagnostic catheter (Newtech, New Delhi, India) was used to cannulate right coronary artery. During the first shoot it was noticed that soft radio-opaque rubber tip of JR had been fractured and embolized into left main artery and proximal right coronary artery was showing 100% stenosis (**Fig. 1a**). The diagnostic JR catheter without tip was removed. Then a selective

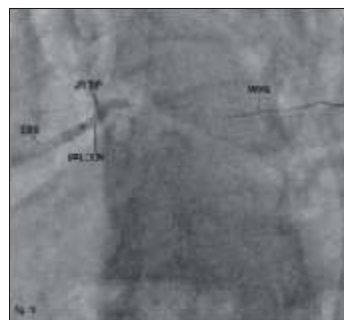
**Fig. 1b :** LA caudal view showing catheterization left coronary with EBU 3.5 catheter Balloon (2x20 mm) passed over the wire (0.014”) into the lumen of JR Tip & then inflated at 7 atm pressure to catch the JR Tip

angiogram of left coronary artery had done with 6F extra back up (EBU) 3.5 (Medtronic, Minneapolis, MN USA) which showed embolized JR tip in distal left main stem at its bifurcation. As there was already a 90% stenosis in distal left main the tip didn't embolized further into the branches. A Cougar XT 0.014" J-tip wire (Medtronic, Minneapolis, MN USA) was used to cross the lumen of the embolized tip. Then over wire, Sprinter Legend 2x20 mm balloon (Medtronic, Minneapolis, MN USA) was positioned inside the lumen of the embolized tip and inflated at 7 atm pressure to catch the tip (**Fig. 1b**). After catching, the tip with whole catheter system was removed through the femoral sheath (**Fig. 2a,b,c**). Later the patient was sent for coronary artery bypass surgery as patient was having severe triple vessel disease. Post procedure hospital stay was uneventful.

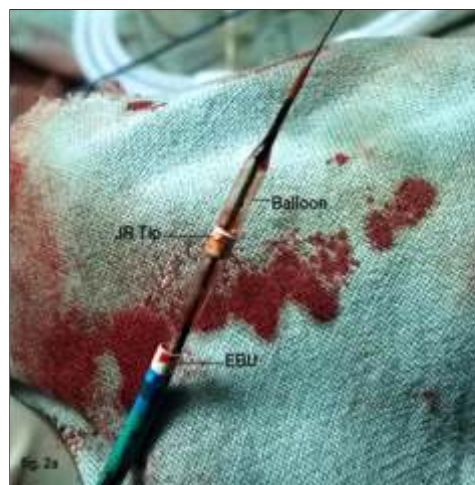
**Fig. 2a :** Entire catheter system (EBU, balloon, wire, JR tip) is removed. Embolized JR tip seen around balloon

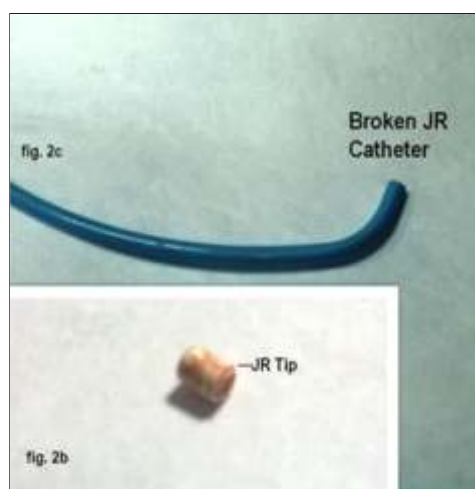
**Fig. 2b :** Embolized JR catheter tip after removal.

**Fig. 2c :** Fractured JR catheter

Fracture of coronary catheters and catheter tip dislocation and embolisation is extremely uncommon and only few case reports exist<sup>2,3</sup>. The factors contributing to fracture of catheters include excessive torquing, forceful withdrawal of catheter which is entrapped in arterial spasm, inappropriate handling of catheters, reuse, manufacturing flaws, inadvertent passage of large catheter through smaller sized access site sheaths, polymeraging or a combination of factors could lead to fracture of diagnostic angiography catheter tip<sup>4</sup>. In our case Glutaraldehyde sterilized reused catheter could be the cause of distal tip fracture.
